JOHN WAYNE MARINA – Property Condition Assessment

March 2019

Reid Middleton

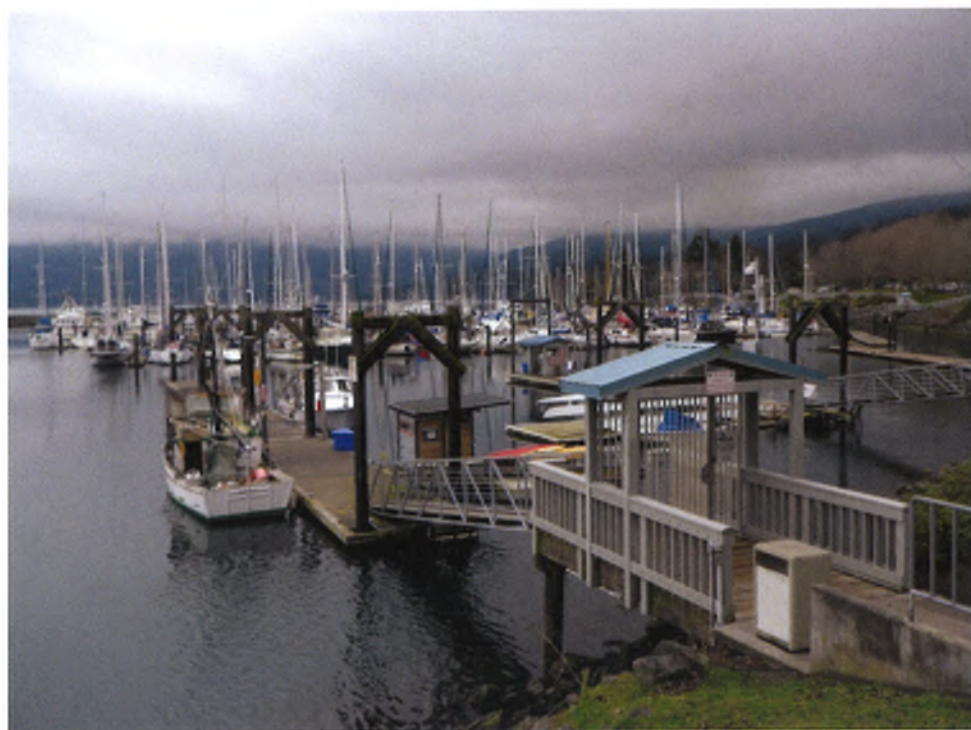
PHOTO No. 1:

John Wayne Marina,
Looking Southeast –
Note the Guest Float
(center) and Fuel
Float (right) in the
foreground and the
marina mooring
floats in the
background.

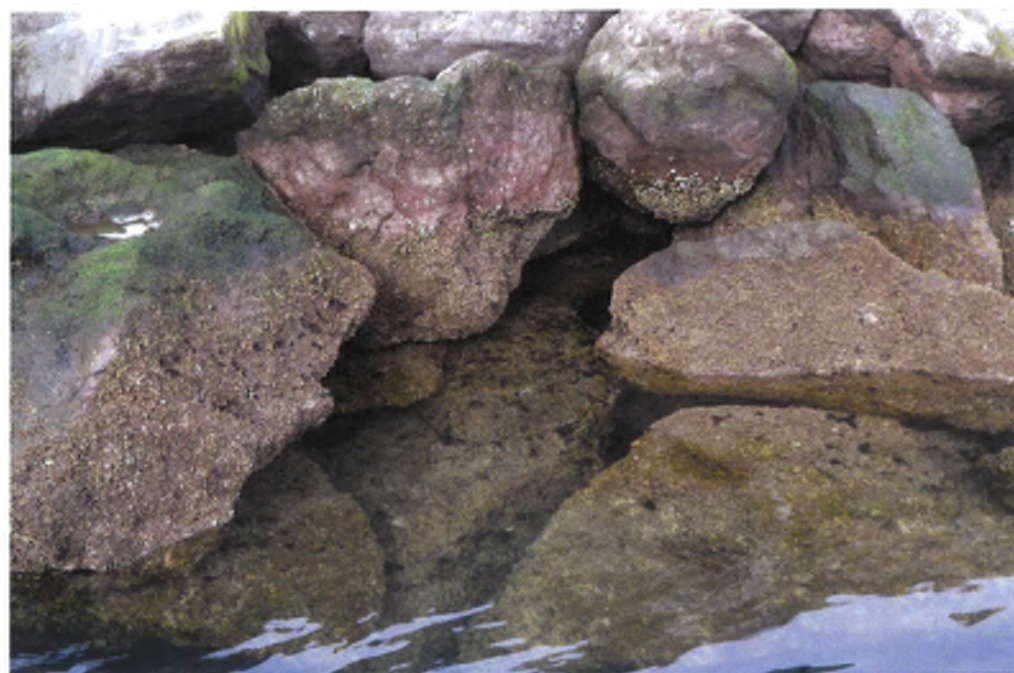
PHOTO No. 30: Breakwater, Typical Construction – Note the apparent stability of the slope as represented by the interlocking of the individual stones. Visual inspection of the underwater portions of the Breakwater did not identify any areas of significant sloughing or loss of stone along the inside or outside of the breakwater.

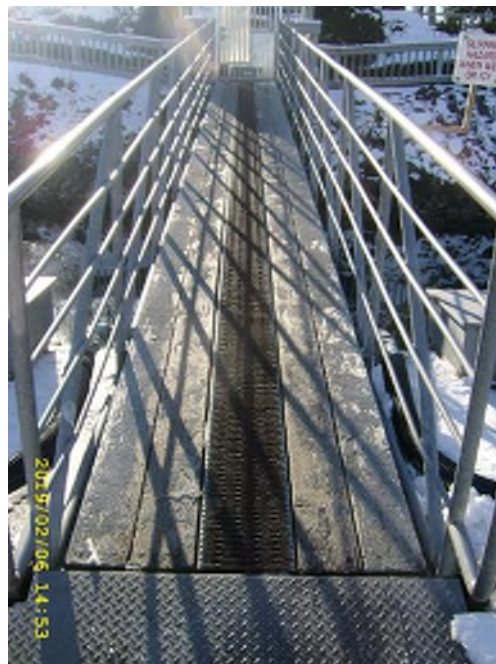
Figure 4. E and F Float Gangway Rusted Grating and Worn Non-Skid Coating

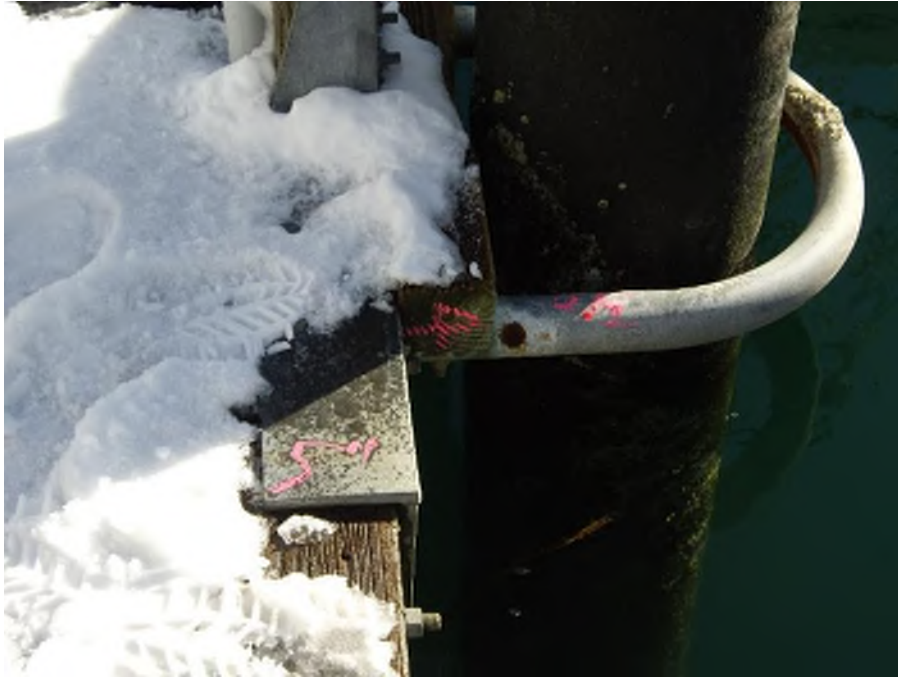
Figure 9. Float B – Typical Pile Hoop Corrosion

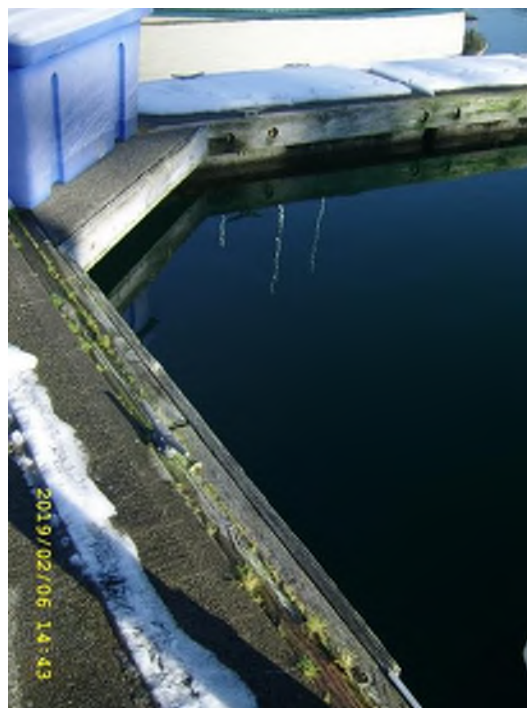
Figure 14. Floats B/C/D – Typical Growth and Deterioration at Timber Walers

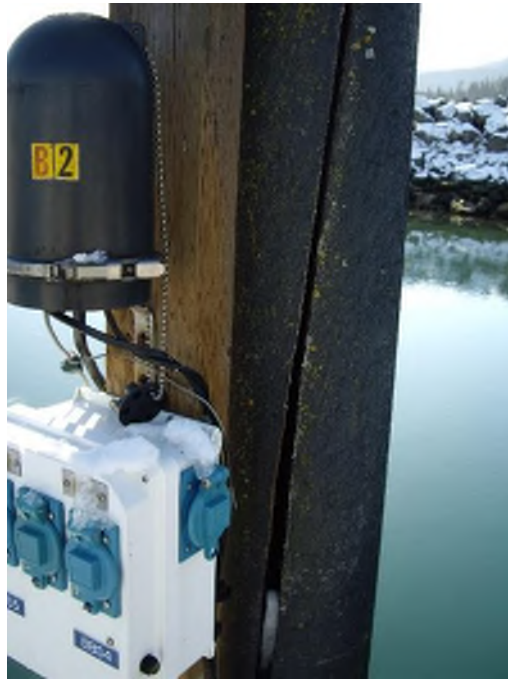
Figure 17. Float B – Major Damage Vertical Crack in Plastic Pile

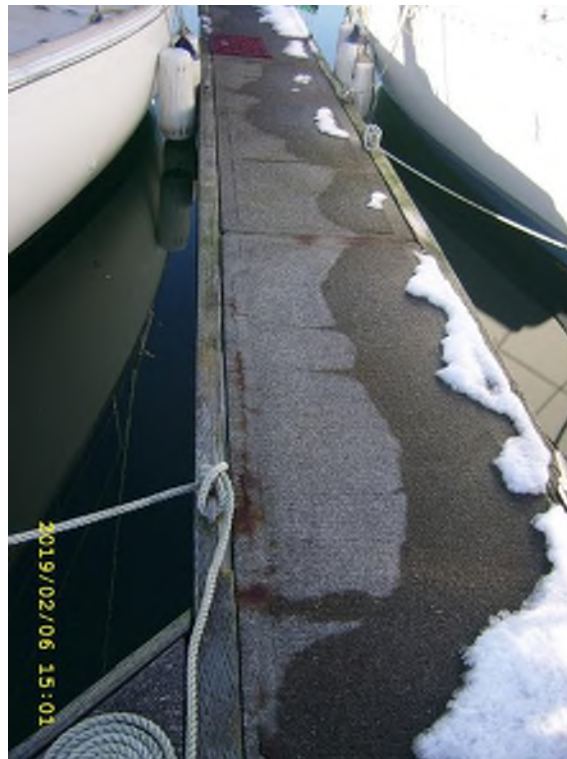
Figure 20. Floats E/F – Cracking and Rust Staining on Concrete Floats

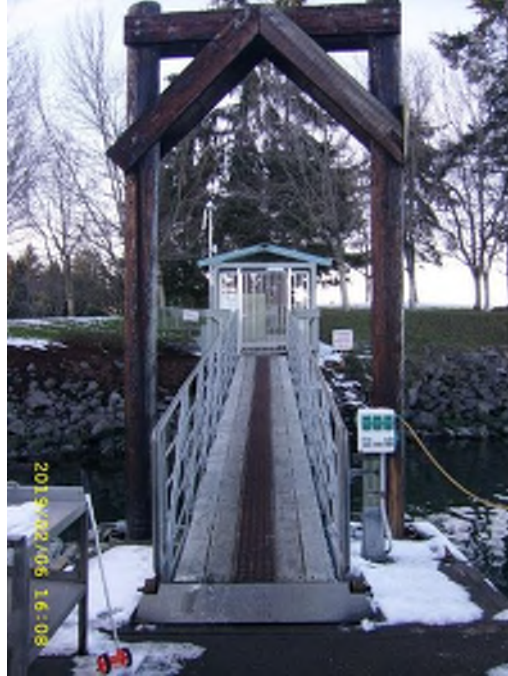
Figure 33. Guest Float – Gangway Condition. Note Rusted Grating & Worn Non-Skid Coating.

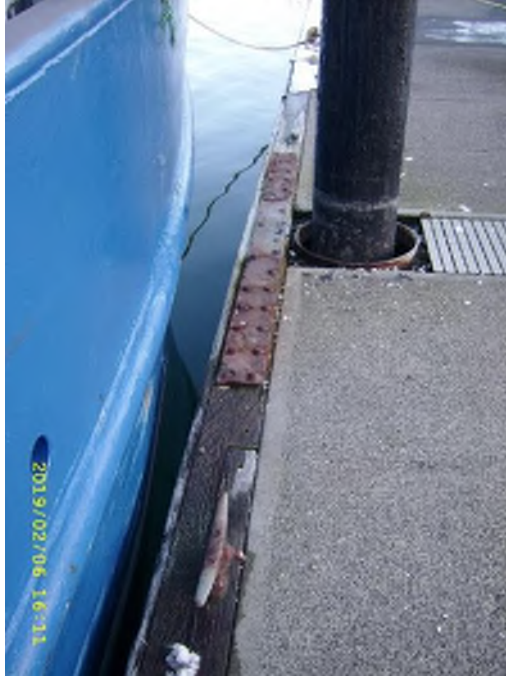
Figure 35. Guest Float – Rusty Pile Hoop and Hardware

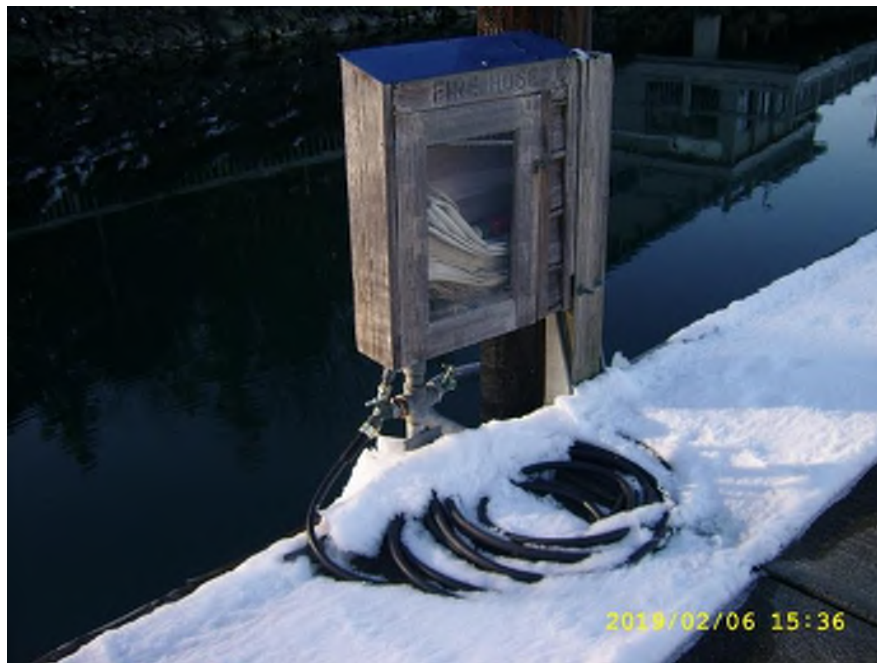
Figure 54. Marina Utilities – Typical Hose Cabinet Deterioration

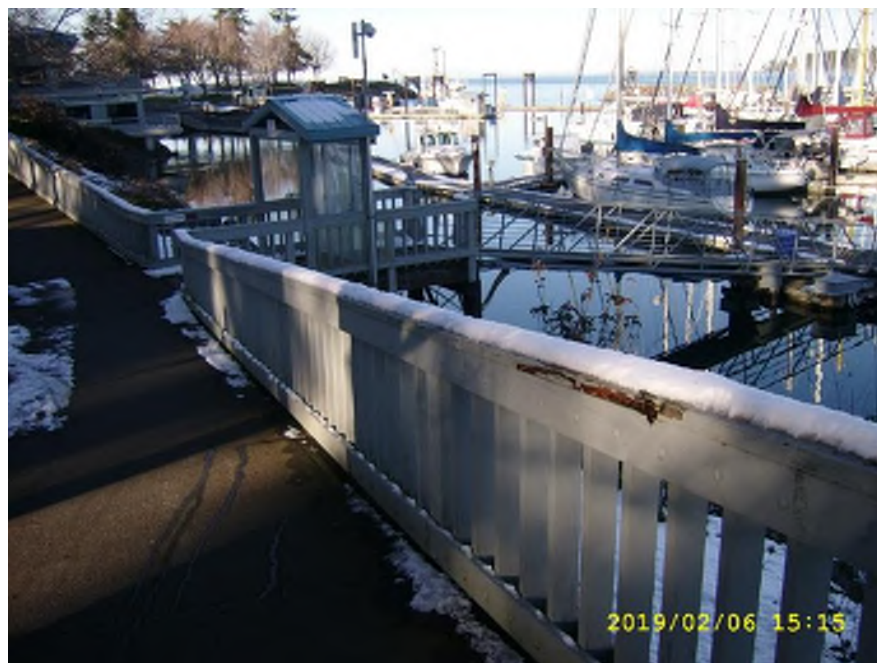
Figure 60. Guardrail – Typical Timber Guardrail Damage / Deterioration

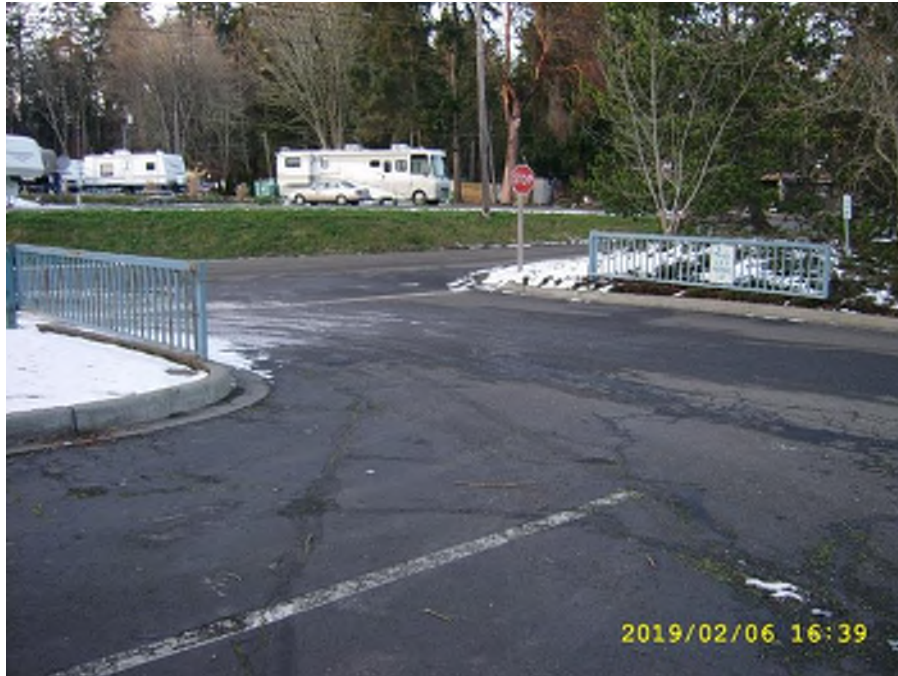
Figure 63. Site Paving – Cracked Pavement with Vegetation Growth.

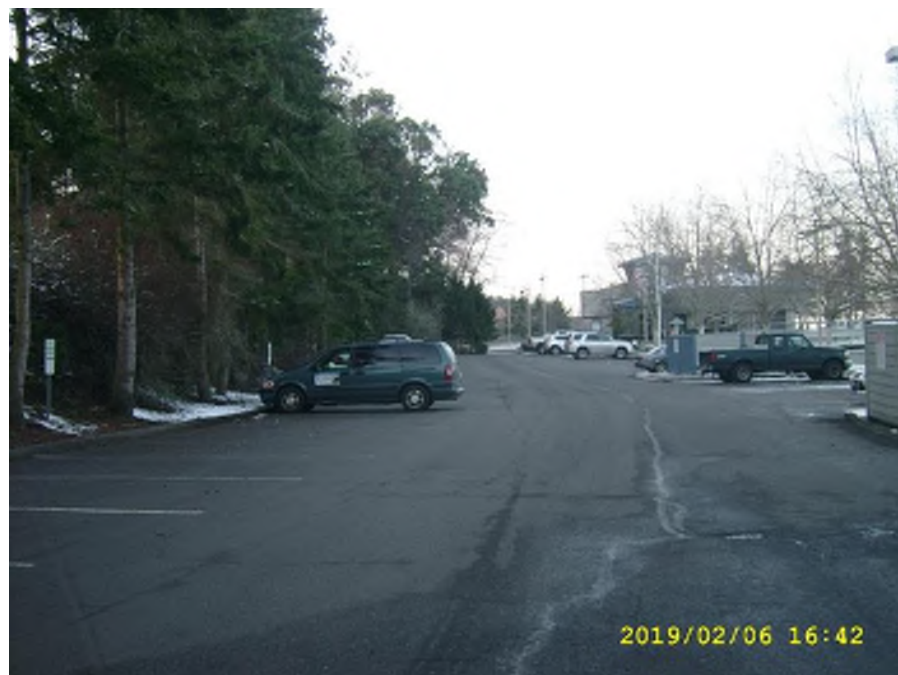
Figure 64. Site Paving – Parking Stall Striping Worn.

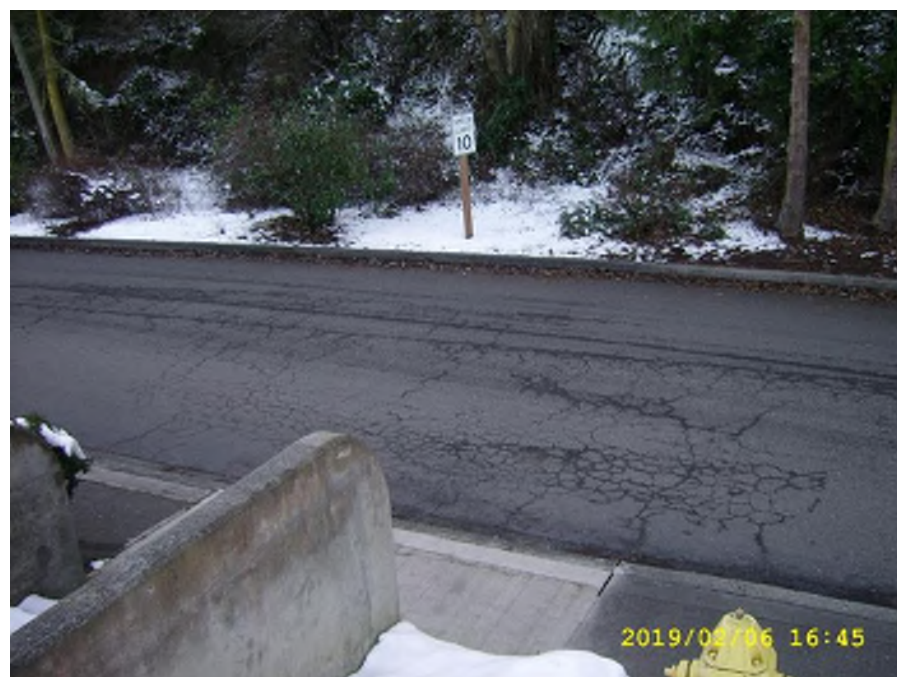
Figure 66. Site Paving – Typical Cracked Pavement

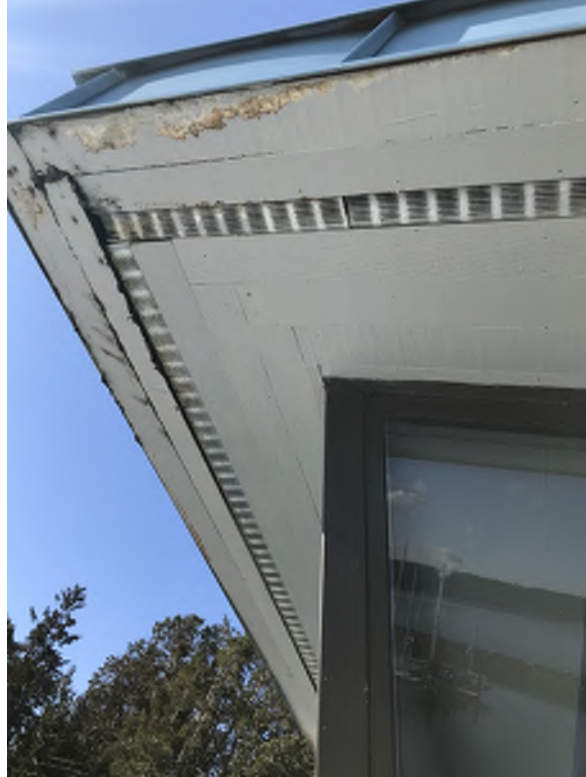
Figure 3. Administration Building – Damage to Soffit from Gutter Leakage

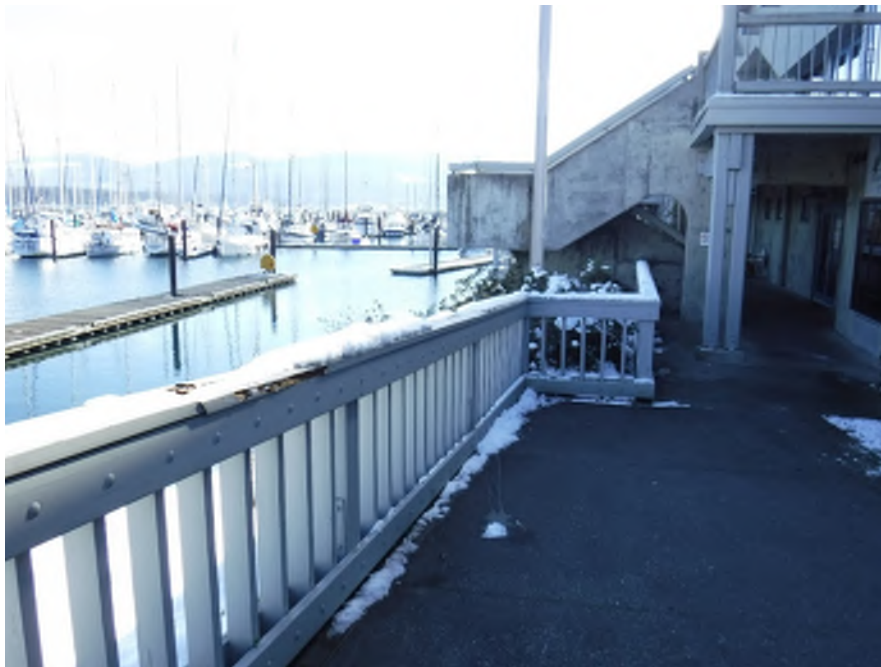
Figure 4. Administration Building – Damage to Top Rail at Ramp Railing

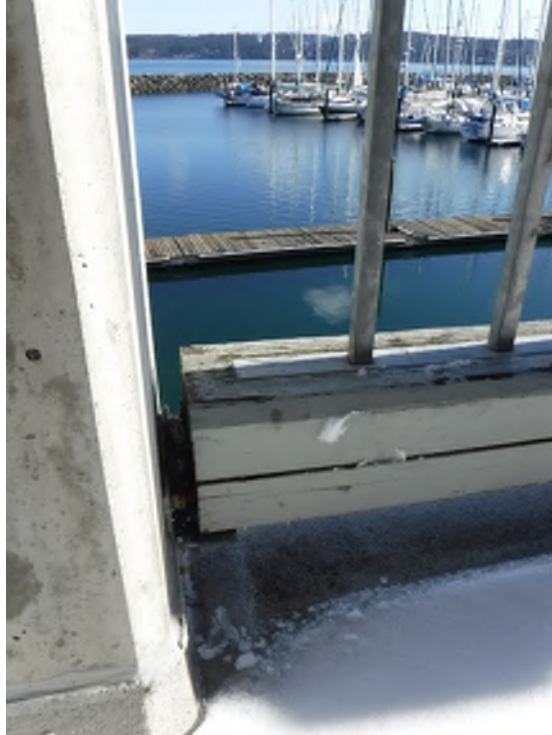
Figure 5. Administration Building – Wood Splitting and Corrosion on Steel Members at Deck

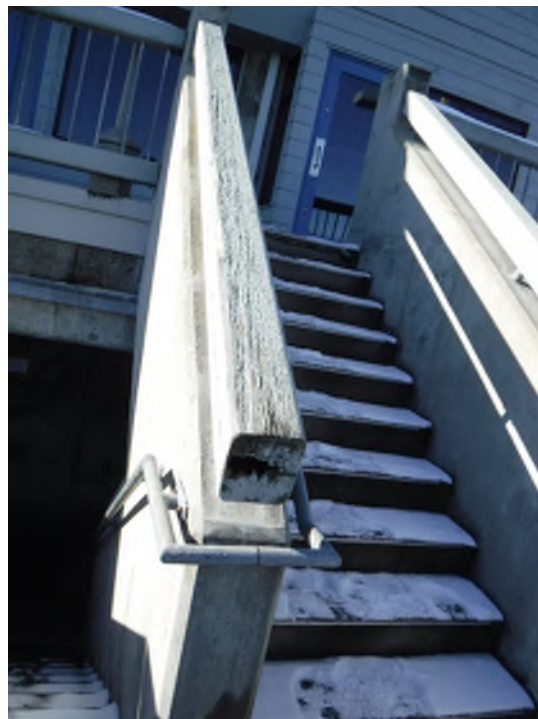
Figure 6. Administration Building – Damage to Top Rail at North Stair
